Cardiff Sanitary Sewer Assessment

Inflow & Infiltration
Committee of the Whole
January 23, 2018

Cardiff Sanitary Sewer Condition Assessment

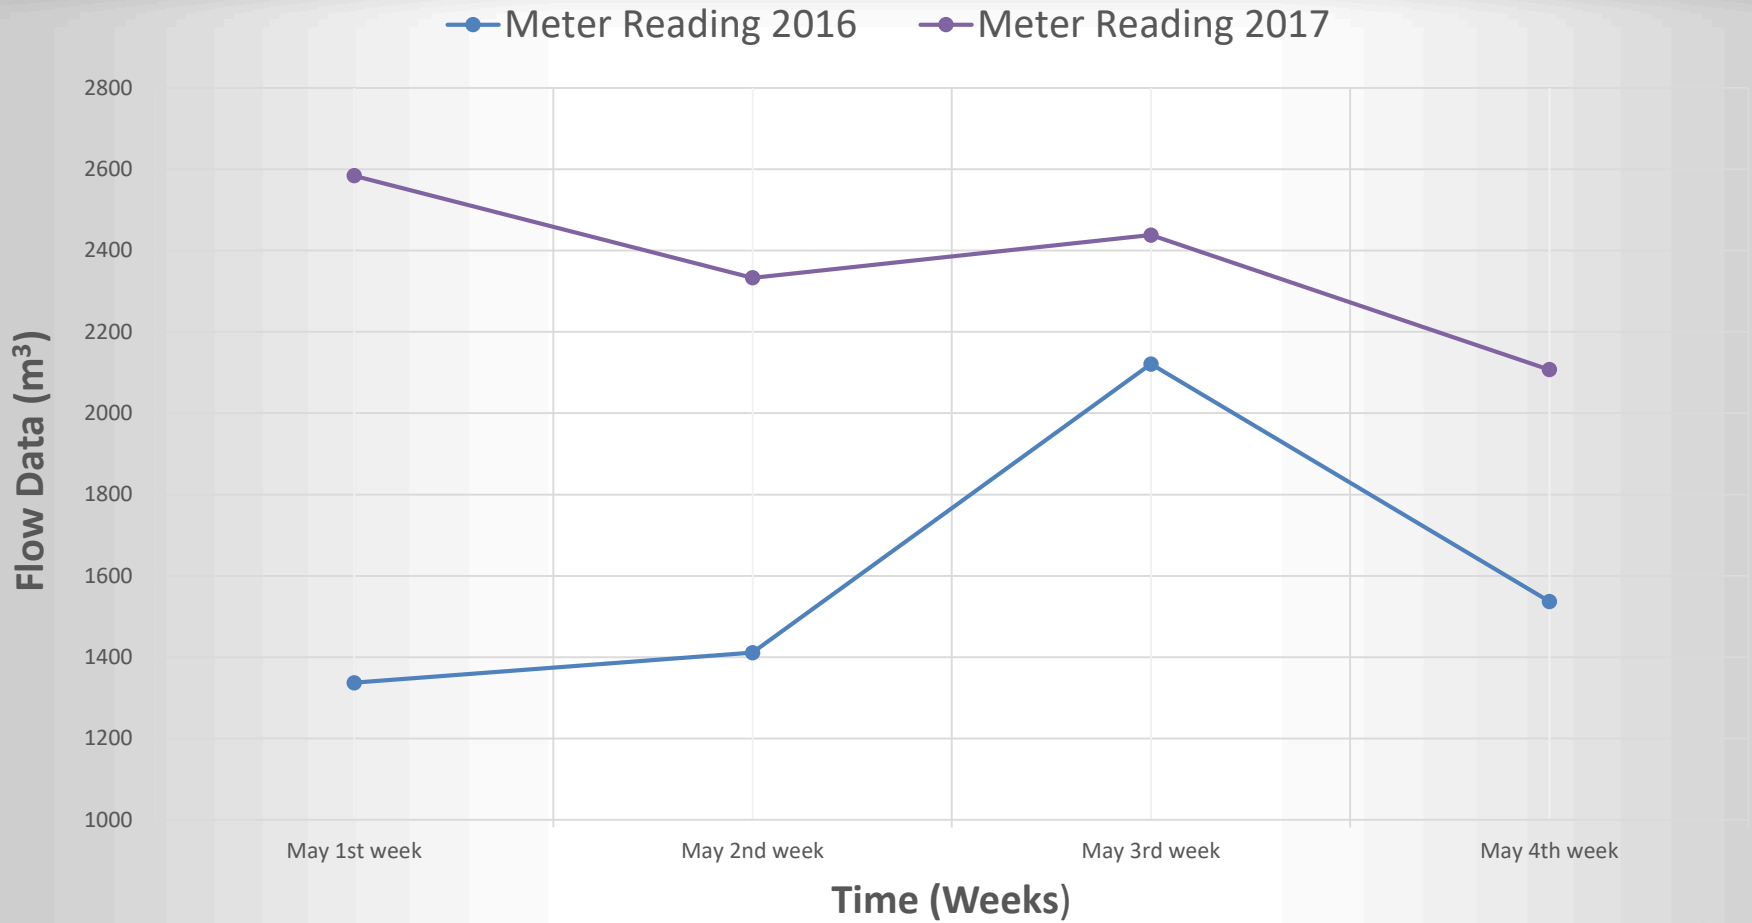
Inflow/Infiltration Study

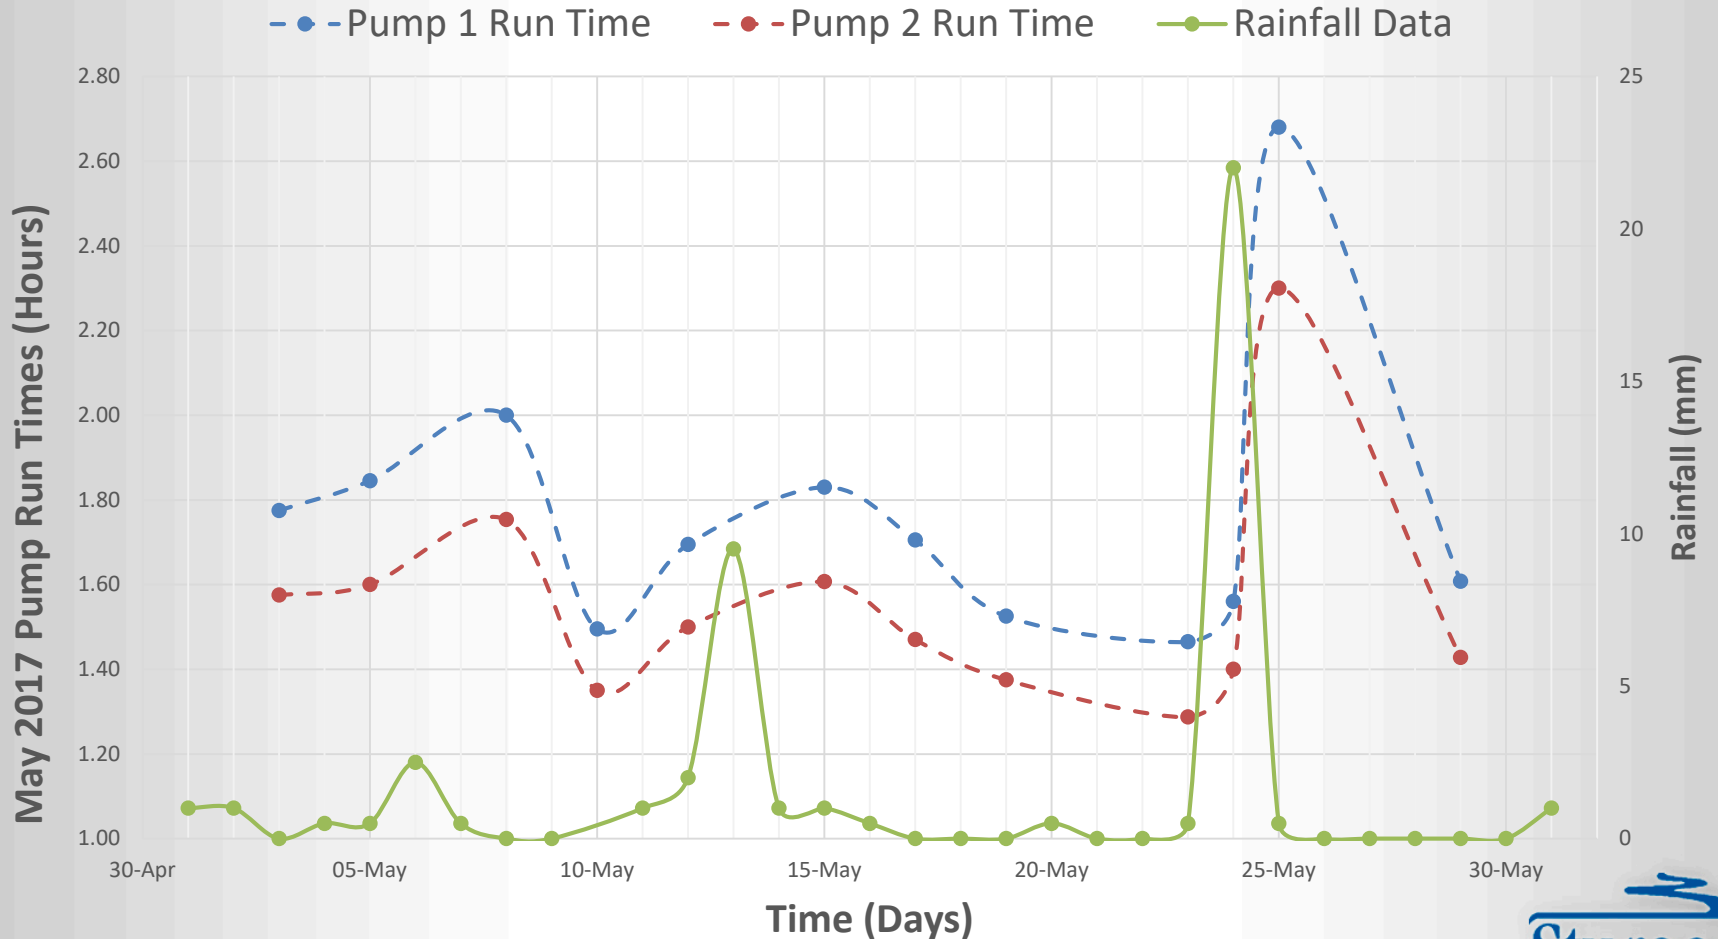
Inflow/Infiltration Study

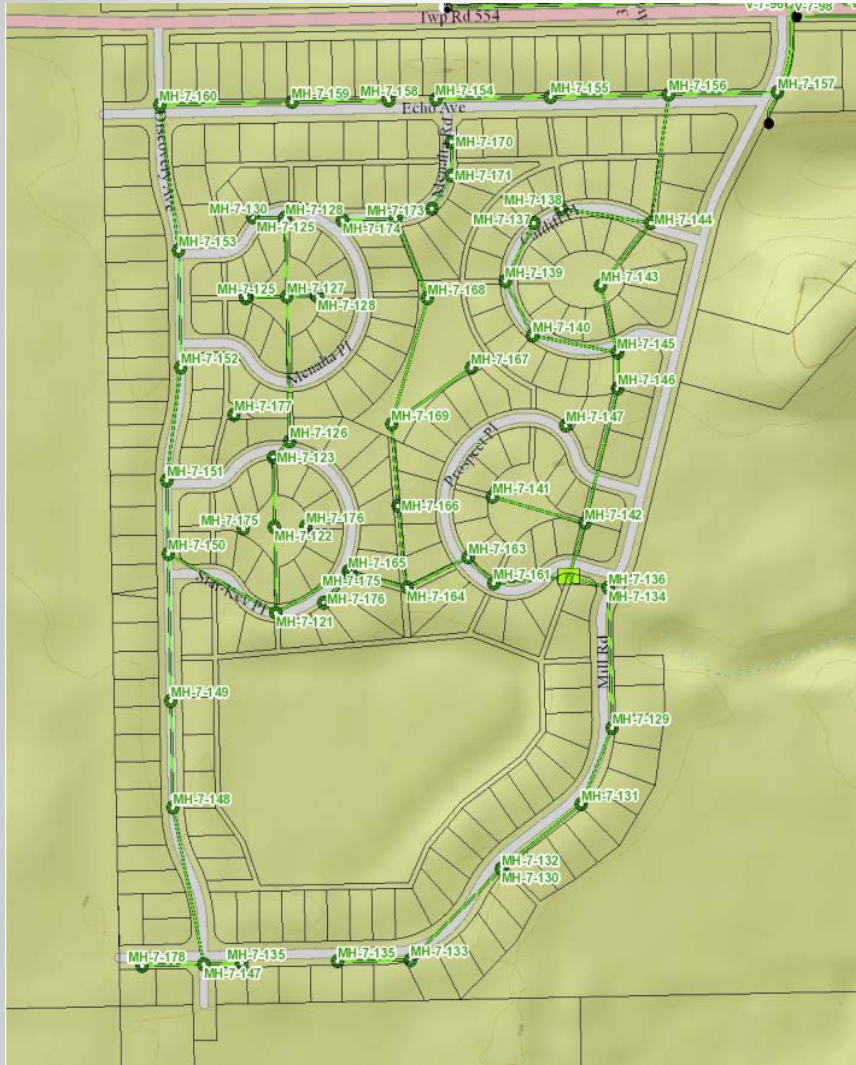
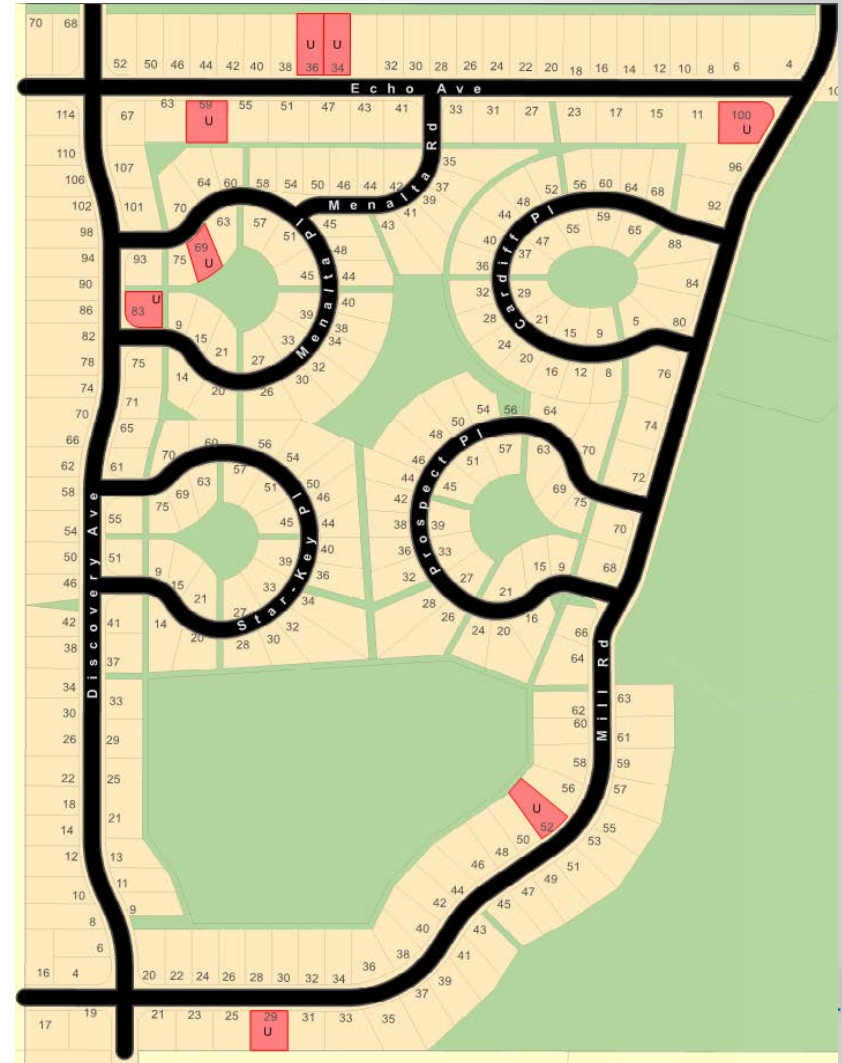
- Objective to further examine surface inflow.
- Two main areas of concern:
 - Manhole covers
 - Private storm connections
 - Downspouts
 - Weeping tiles
 - Sump pump connections
