To: **Sturgeon County** Date: **August 21, 2017**
Attention: **Jeff Yanew, C.E.T., Utility Operations Supervisor** Project No.: **14929**
Cc: **Greg Germain, E.I.T**
Reference: **Hamlet of Cardiff – Sanitary Sewer Condition Assessments**
From: **Stephen McCauley, P.Eng., & Priyanka Joshi, E.I.T**

The objective of this memorandum is to summarize the findings of the analysis and inspection completed by ISL and the resulting rehabilitation and staging recommendations, along with the corresponding financial implications.

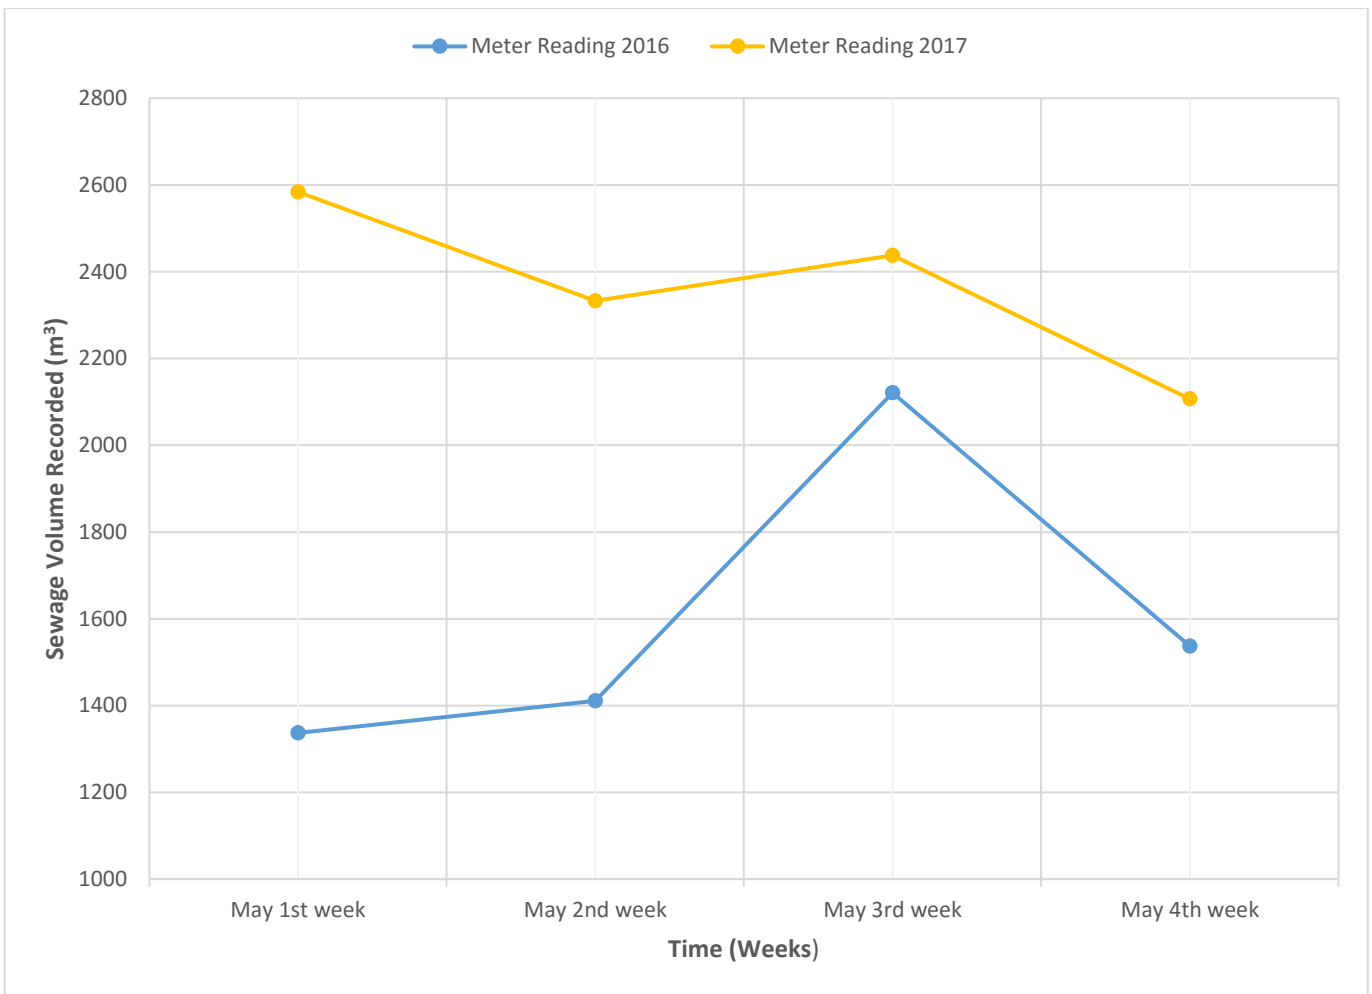
Figure 2.1 illustrates the sewage volumes recorded by the lift station flow meter in May of 2016 and 2017 graphically. As can be seen from the figure, compared to May 2016, the lift station accumulated a larger volume of wastewater in May of 2017. Provided there was no significant population and/or per capita consumption increase in Cardiff between the period of May 2016 and May 2017, the increased volumes in May 2017 can be attributed to heavy precipitation, thus resulting in high volumes of I/I into the system. However it is not possible to quantify how much of the increased flow is due to inflow and how much is resulting from infiltration from the data presented in Figure 2.1 alone.

Figure 2.1: May 2016 and May 2017 Lift Station Flow Meter Readings

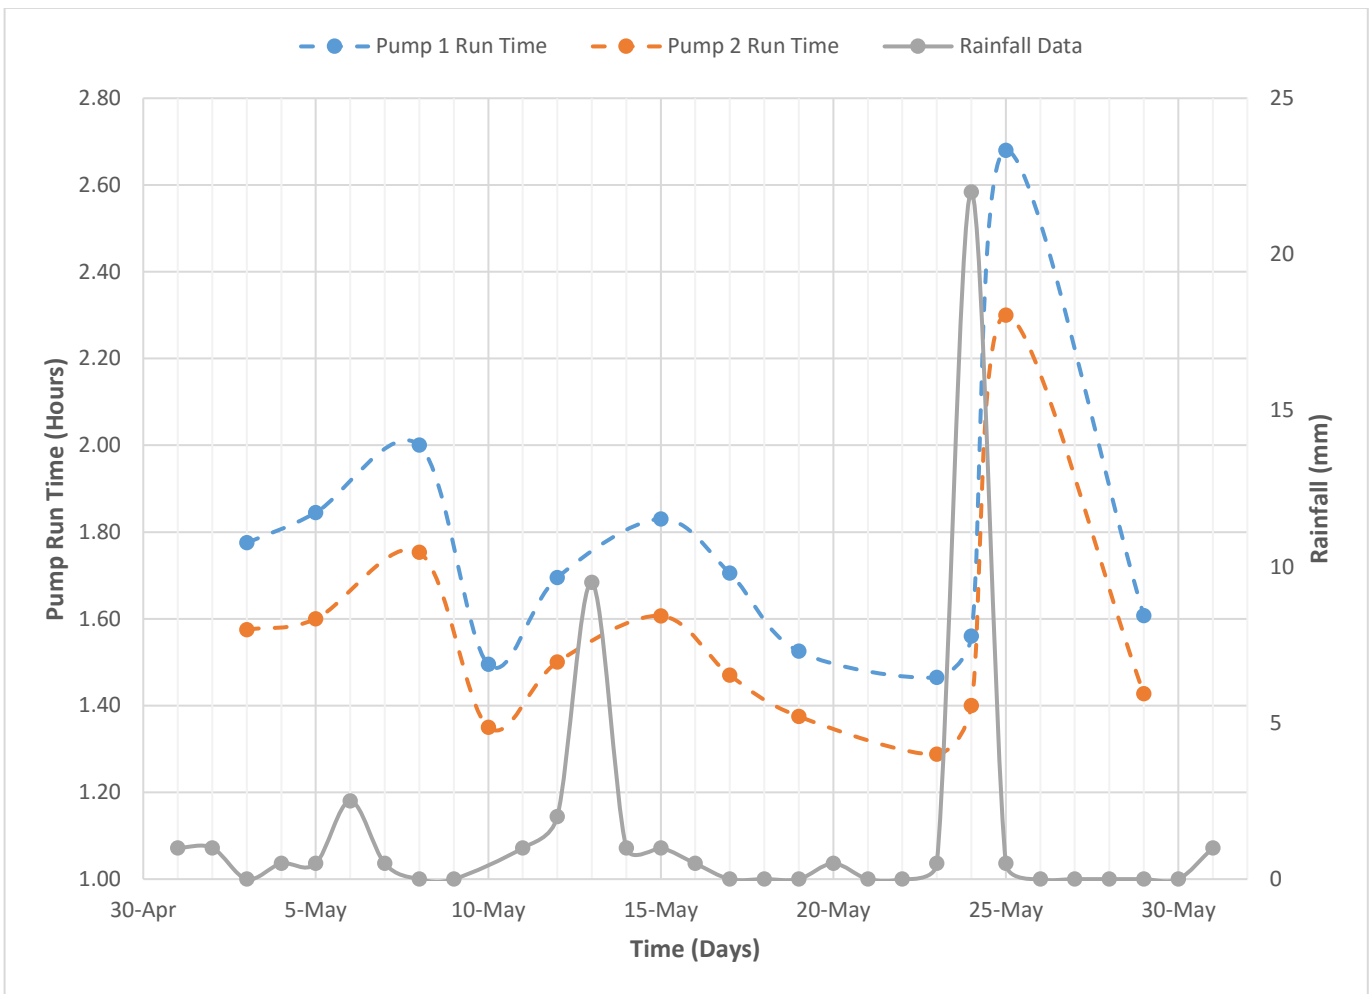
In an attempt to further understand whether the primary contributor of the higher flows in May 2017 was inflow or infiltration, ISL compared the pump run times for May 2017 provided by the County with the historical rainfall data for the Hamlet of Namao (Namao) for May 2017, obtained from the Weather Network. No rainfall data was available for Cardiff, therefore rainfall data for Namao was used for this analysis. Figure 2.2 provides a graphical representation of the pump run times and the rainfall data during the month of May 2017. It is evident from Figure 2.2 that the peak rainfall events do not exactly coincide with the peaks in the pump run times. There is a lag of about 1 to 2 days in the spike in pump run times after each heavy rainfall event. This is an indication that the increase in flows is more likely a result of infiltration and less likely from inflow.

Figure 2.2: May 2017 Pump Run Times and Rainfall Data

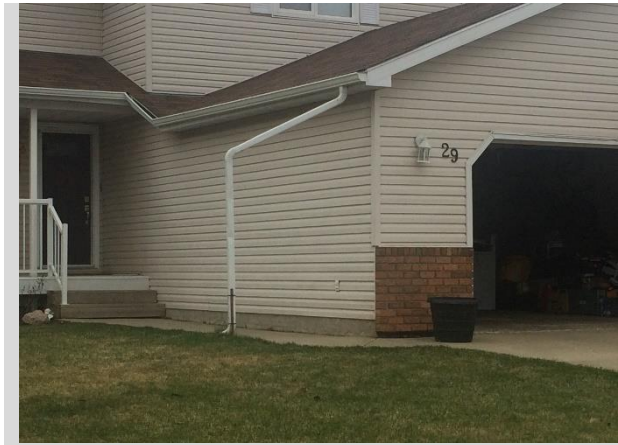
Image 2.1 Downspout House 29

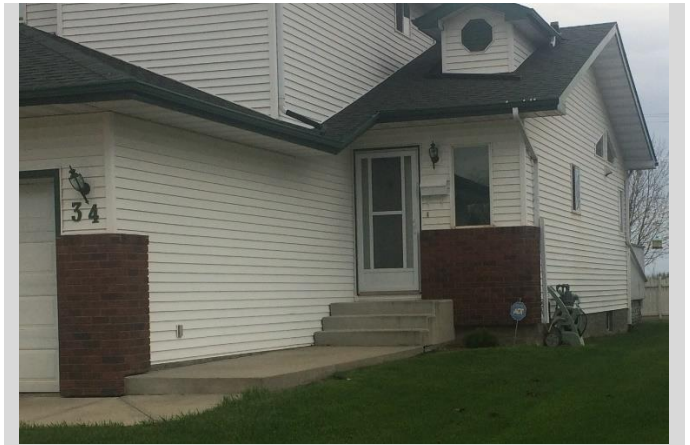
ISL would like to point out that although previously thought to be connected to the sanitary system, the downspouts from Houses 34 and 83 are not tied into the sanitary system.

Image 2.2 Downspout House 34
(Not connected to sanitary system)

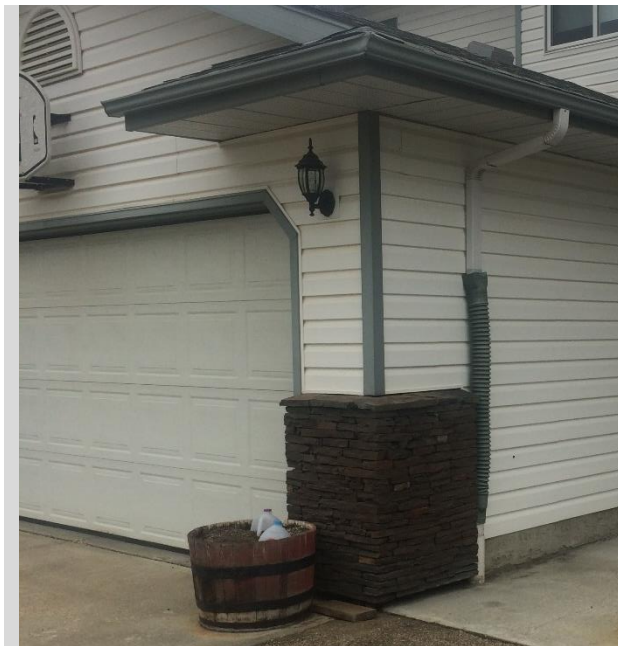
Image 2.3 Downspout House 36

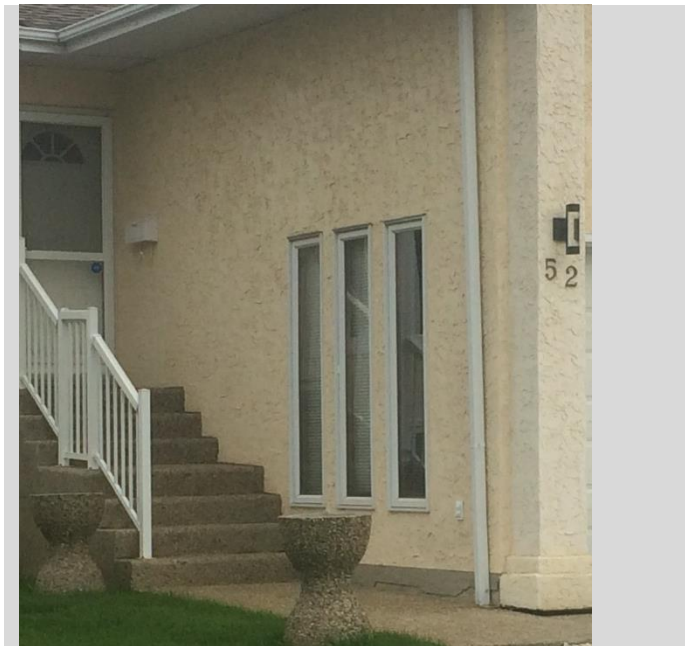
Image 2.4 Downspout House 52

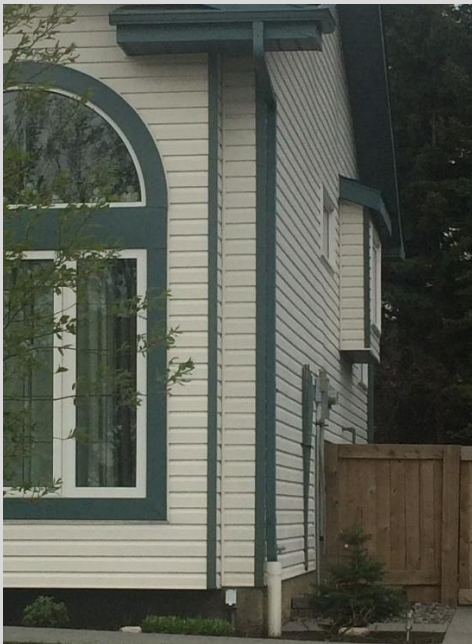
Image 2.5 Downspout House 59

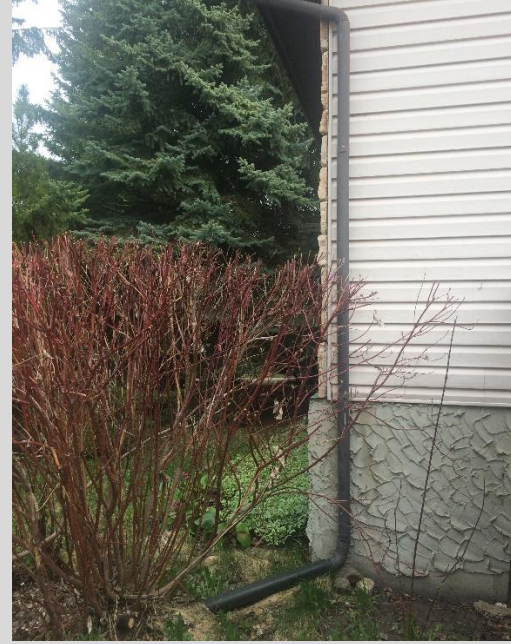
Image 2.6 Downspout House 69

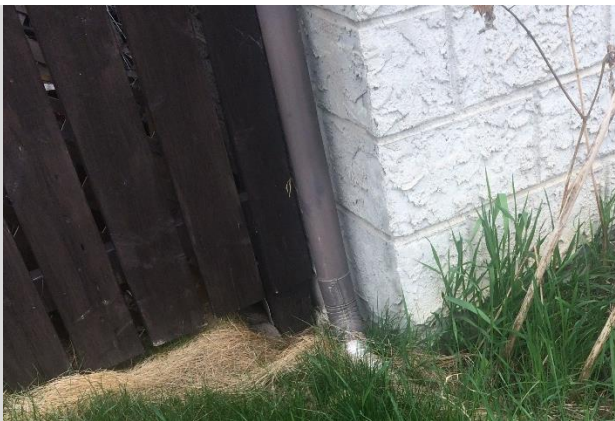
Image 2.7 Downspout House 83
(Not connected to sanitary system)

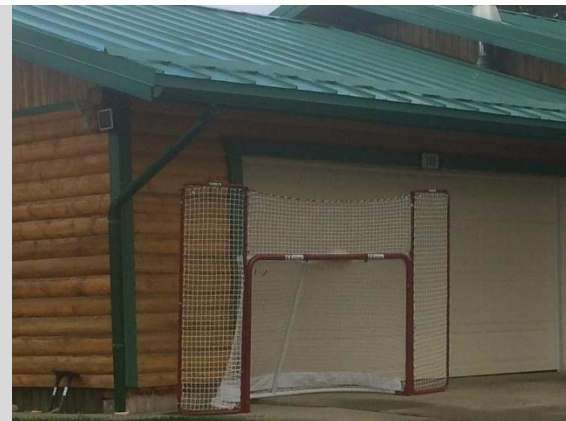
Image 2.8 Downspout House 100
