May 9, 2018

Sturgeon County  
9613 100 Street  
Morinville, Alberta  
T8R 1L9

**Range Road 261A Initial Slope Assessment  
Call – Out Report**

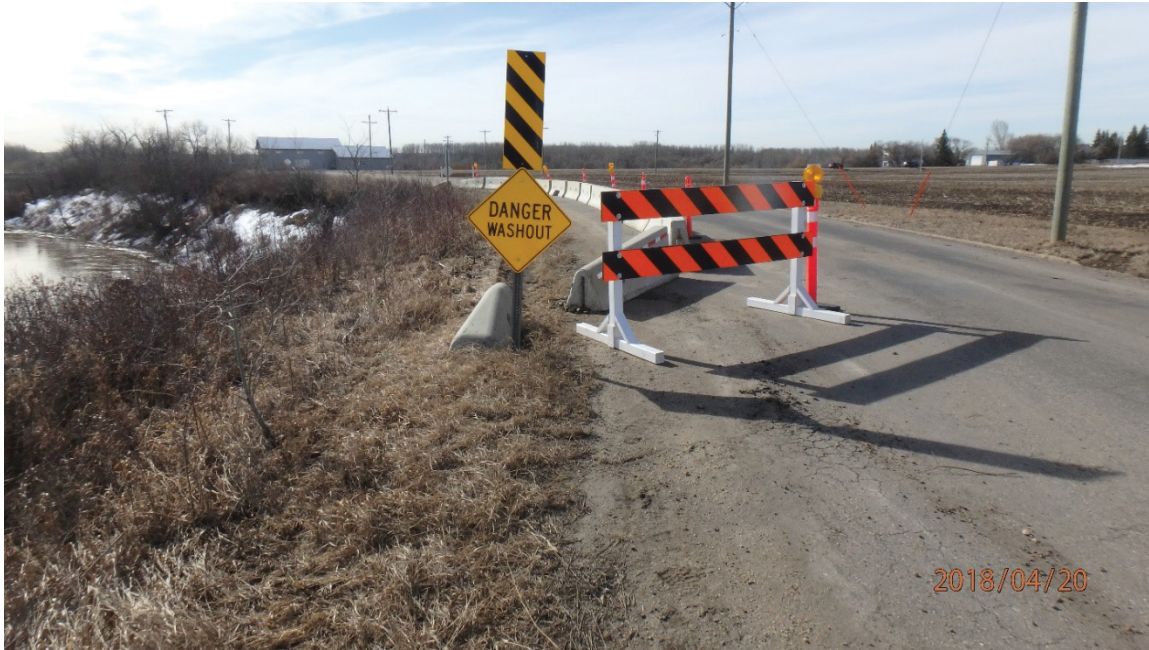
- The jersey-barrier is approximately 40 m long, and long enough to limit vehicle access to the crest of the failed slope. The north end of the jersey-barrier barricade (see Photo 1) is indicated at waypoint 587, shown on Figure 1. The south end of the jersey-barrier barricade (see Photo 2) is indicated at waypoint 588, shown on Figure 1.

**Photo 1** View of site from north. Photo taken on April 20, 2018 looking south.

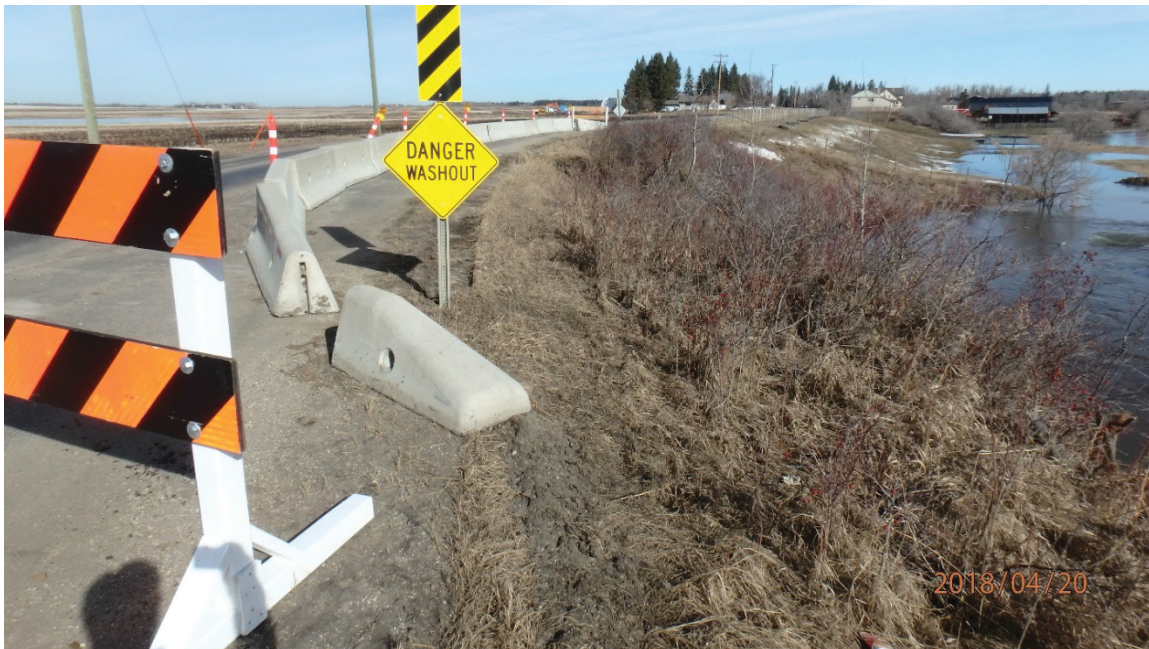
**Photo 2** View of site from the south. Photo taken on April 20, 2018 looking north west.

The slide appears to be expanding to the south and as erosion continues, the slide will eventually extend past the southern edge of the jersey-barrier barricade. As an immediate short-term mitigation, we recommend extending the southern edge of the jersey-barrier barricade approximately 20 m south of the active slide.

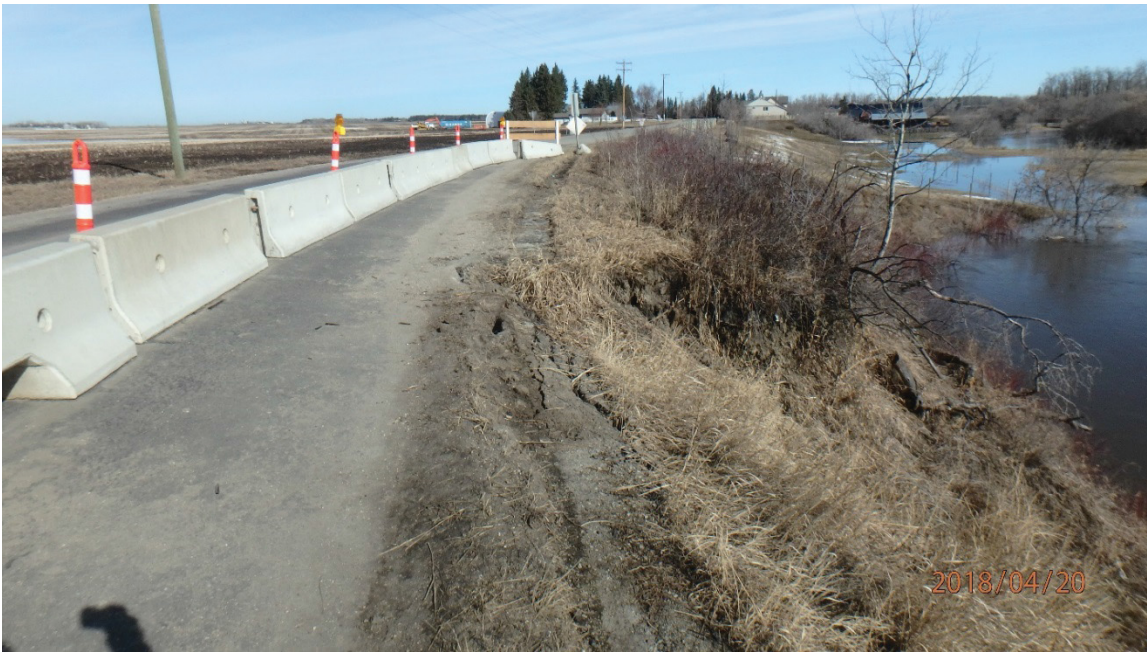
- The slope failure has retrogressed past the eastern edge of pavement in spring of 2018 (see Photo 3).
- Parts of the slope were still covered with snow and high water in Sturgeon River inundated the toe of the slope, precluding inspection of the toe for erosion (see Photo 4 and Photo 5).

**Photo 3** Slope failure retrogressed past edge of pavement in spring of 2018. Photo taken on April 20, 2018 looking north.

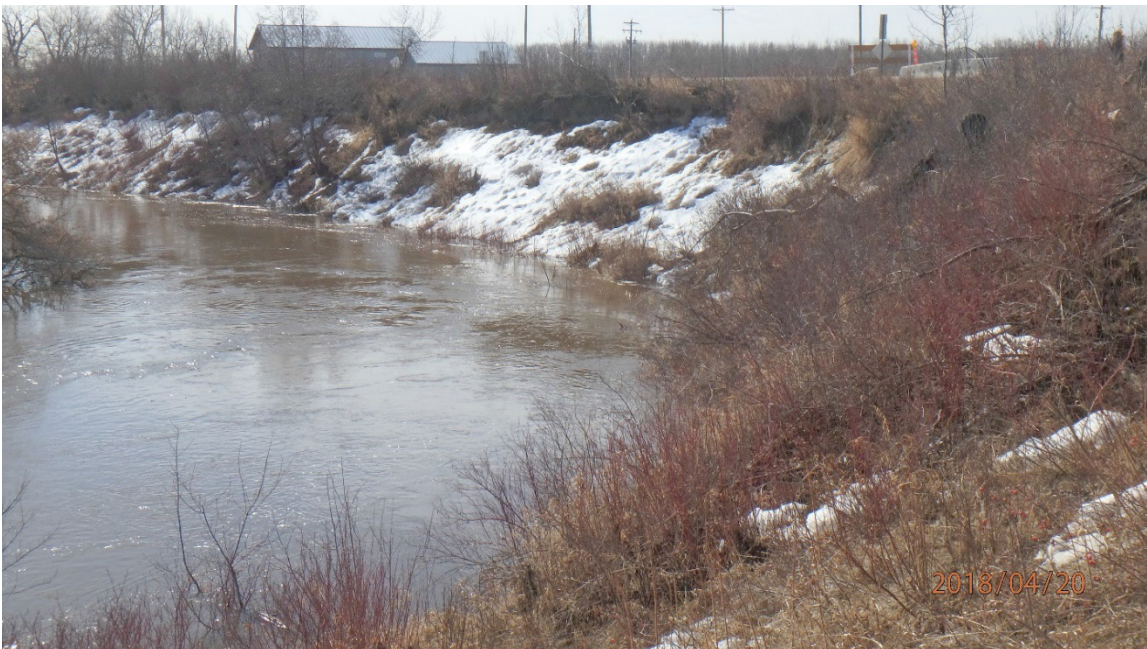
- The slide area appears to be an older slope failure that has been re-activated, as indicated by the eroded slope upstream of Sturgeon River bridge (see Photos 4 and 8)

**Photo 4** Portions of the slope with a north facing aspect were still covered with snow at the time of KCB's site visit. Note highwater in Sturgeon River that precluded inspection of the toe of the slope at normal water level. Photo taken on April 20, 2018 looking south east.

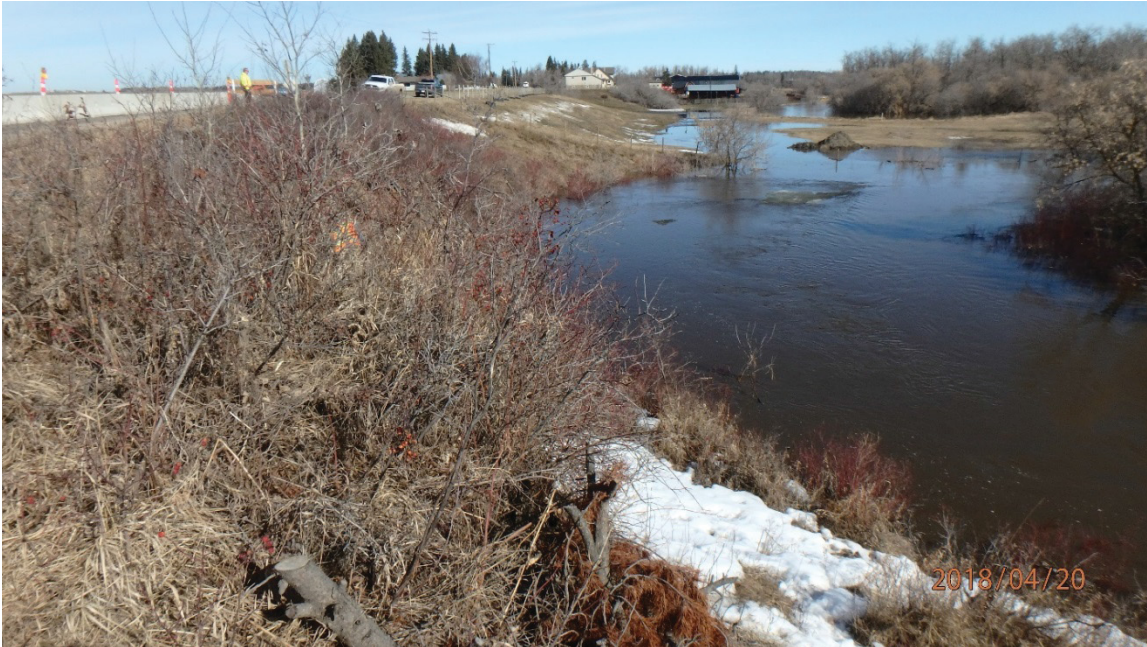
**Photo 5** Northern portion of slope on flanks of slope failure area. Note highwater in Sturgeon River causing flooding of farmland to north of site. Photo taken on April 20, 2018 looking east.

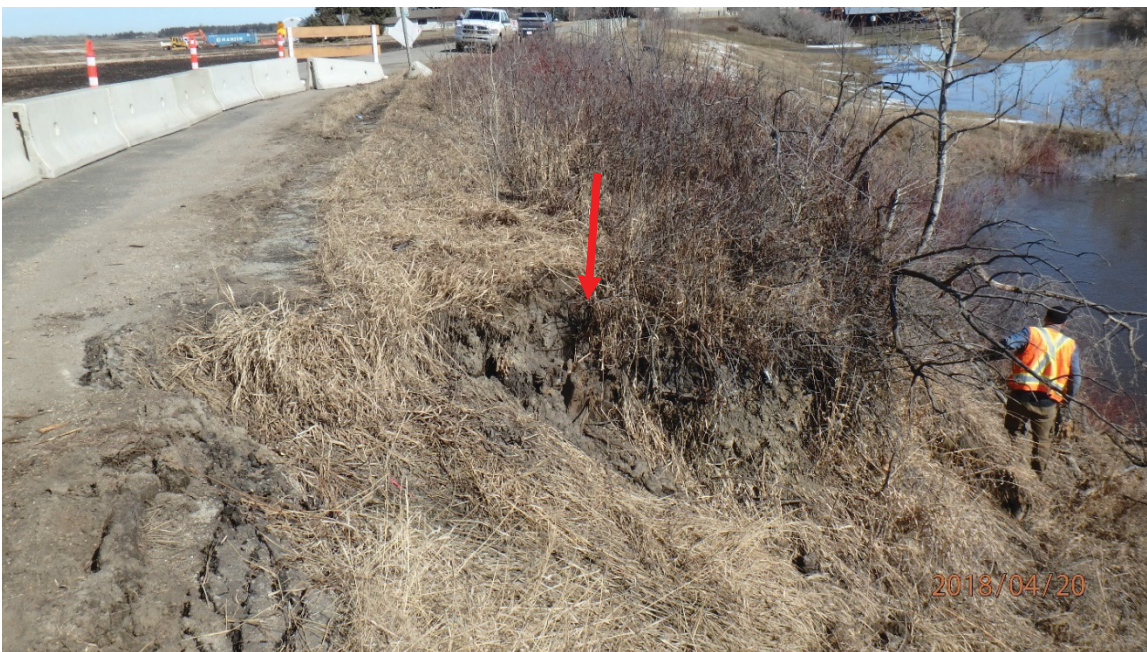
- The slide area is expanding to the north (see Photo 6). An 8-m long tension crack, partially infilled with leaf litter and vegetation was observed to the north of the active slope instability area. The north end of the tension crack is at waypoint 585, shown on Figure 1. The tension crack is located approximately 2 m behind the crest of the slope. The 8-m long section of slope that is failing is behind the jersey-barrier barricade

- Surface water runoff from the range road onto the slope appears to be triggering the slope failure by saturating the slope, and causing erosion of the upper portion of the slide, undermining the pavement (see Photos 6 and 7, reference waypoint 582 on Figure 1)

**Photo 6** A portion of the slope to the north of the active failure zone is in the process of failing, and will enlarge the slide area. Red arrow shows location of ground cracking associated with expansion of slope failure area. Photo taken on April 20, 2018 looking north.

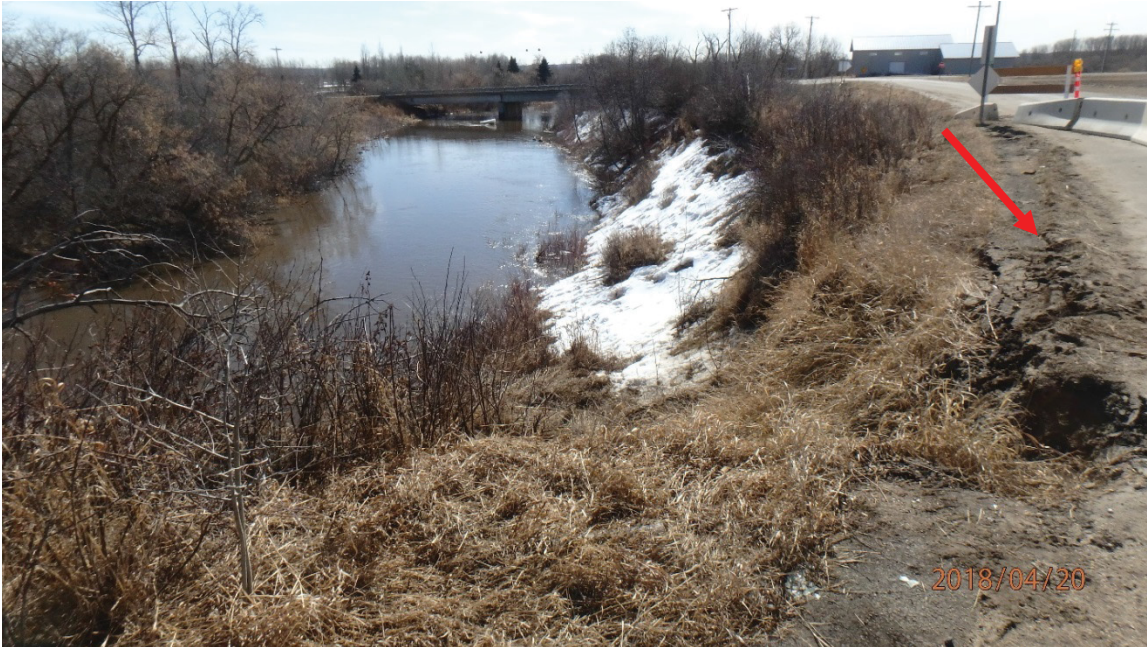
**Photo 7** View of slide area with Meadowview Drive bridge over Sturgeon River in the background. Red arrow shows former location of jersey-barrier barricade. Photo taken on April 20, 2018 looking east.

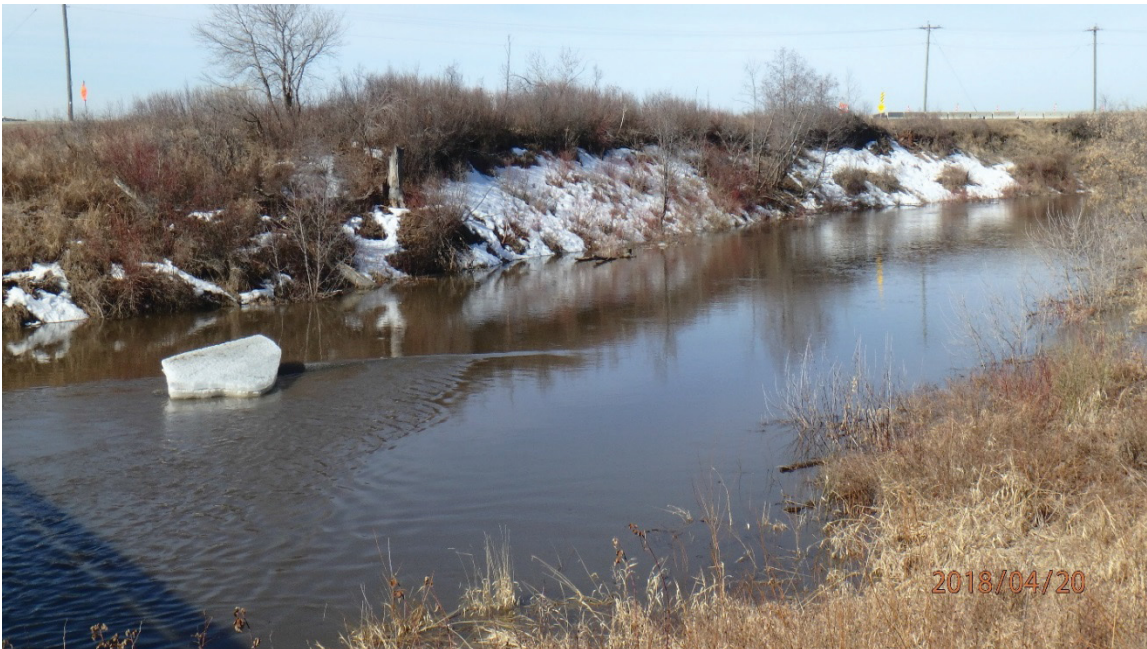
**Photo 8** View of site from Meadowview Drive bridge over Sturgeon River. Photo taken on April 20, 2018 looking west.
